International Imaging Technologies, Inc.

A Qualitative Infrared Thermographic Survey of Electrical Switchgear

**U.S. Postal Service
JAX Processing and Dist. Center
Jacksonville, FL. 32203-9731**

Report No. 1

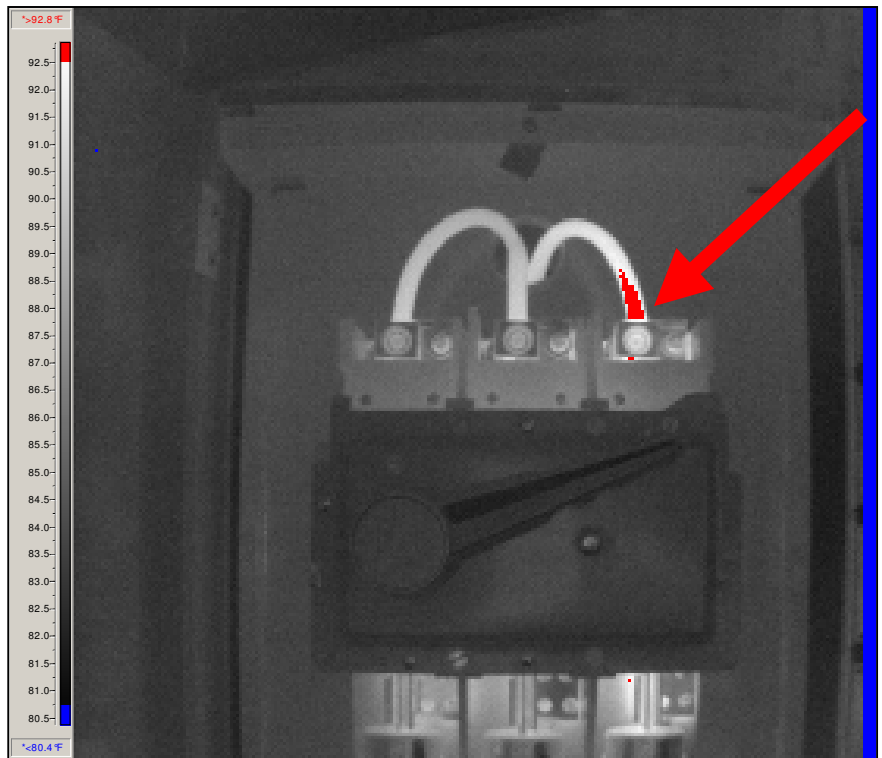
Panel/Equipment
Panel MCC-E/Xformer 75KVA

Ambient temp.	82.3
Reference temp.	89.0
High temp.	94.5
Temp. rise	5.5

DESCRIPTION: Main Disconnect/Phase C, Line Side Lug Heating

RECOMMENDATION: Check Lug connection and Line Side of Disconnect

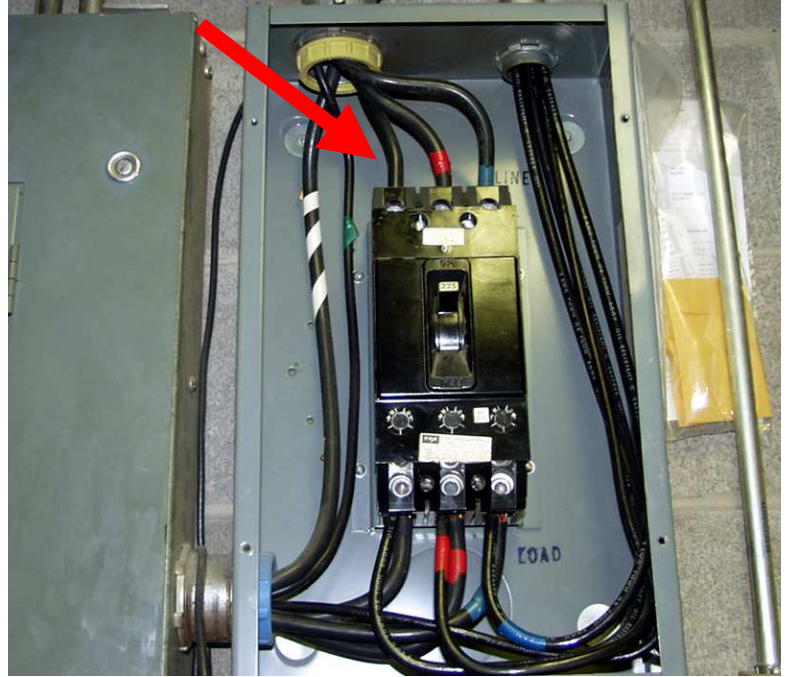
Report No. 12

Panel/Equipment
Main Breaker for Panel PP1-S4

Ambient temp.	80.2
Reference temp.	89.8
High temp.	129.9
Temp. rise	40.1

DESCRIPTION: Breaker Lug/Phase A, Line Side

RECOMMENDATION: Check Lug Connection

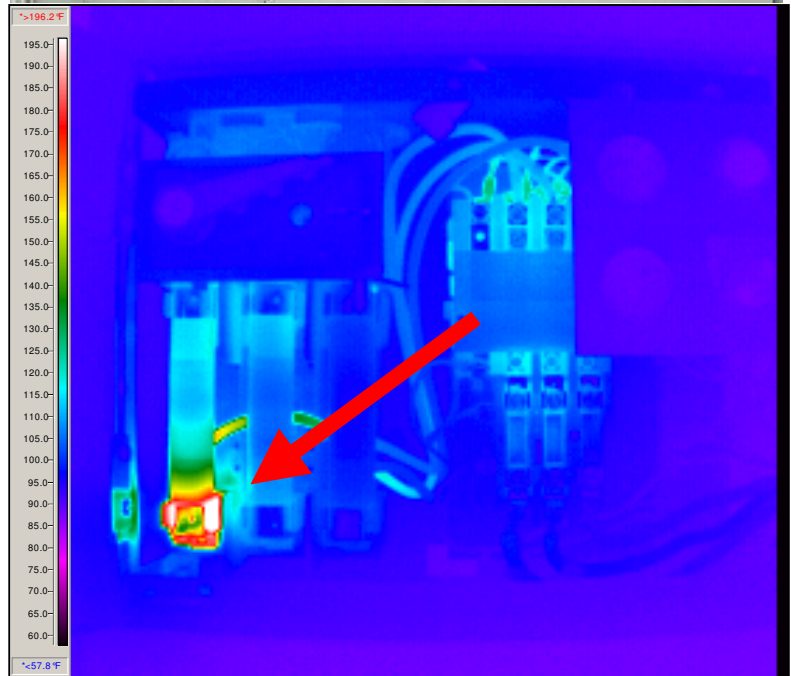
Report No. 15

Panel/Equipment
MCC-G/Cubicle-East Side Ext. Lights

Ambient temp.	86.0
Reference temp.	104.8
High temp.	224.2
Temp. rise	119.4

DESCRIPTION: Fuse and Fuse Clip/Phase A,
Load Side
RECOMMENDATION: Replace Fuse and Fuse
Clip
